Chip Errata for the i.MX27

Silicon Revision: 2.0, 2.1, and 2.2

This document details all known silicon errata for the i.MX27. [Table 1](#) provides a revision history for this document.

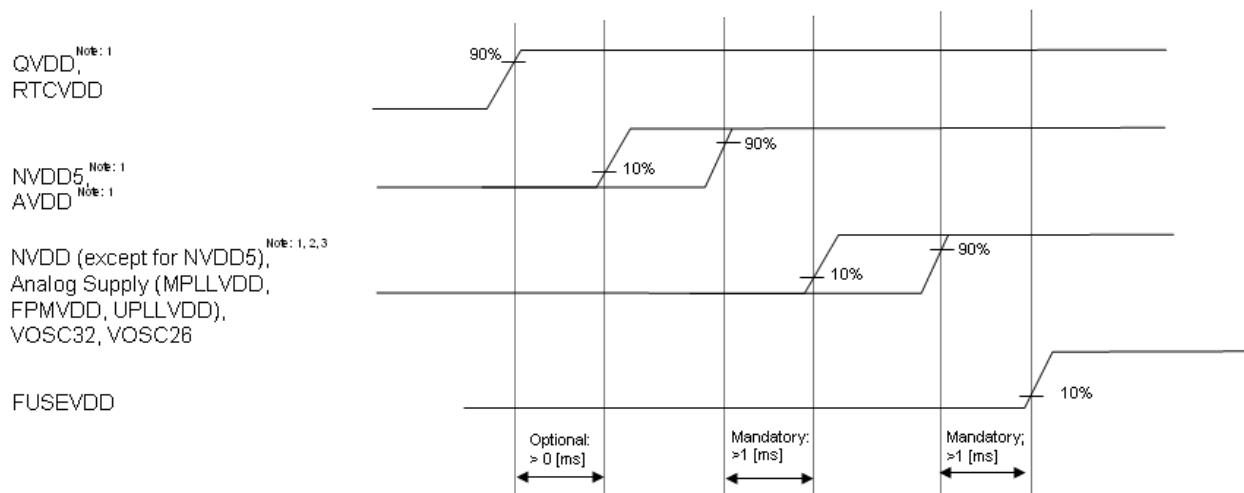
Figure 1. Recommended Power-Up Sequence

(Continued from erratum 10, ID ENGcm11563)

- 1 QVDD, AVDD (IO power for BOOT pin), NVDD5 (IO power for POR_B pin) must be powered up before MPLLVDD.
- 2 MPLLVDD must be driven to 0, not floating, before powering up.
- 3 NVDD supply domain (except for NVDD5) can be turned on either at the same time as MPLLVDD or with NVDD5
