MPC8306S Chip Errata

This document details all known silicon errata for the MPC8306S. The following table provides a revision history for this document.

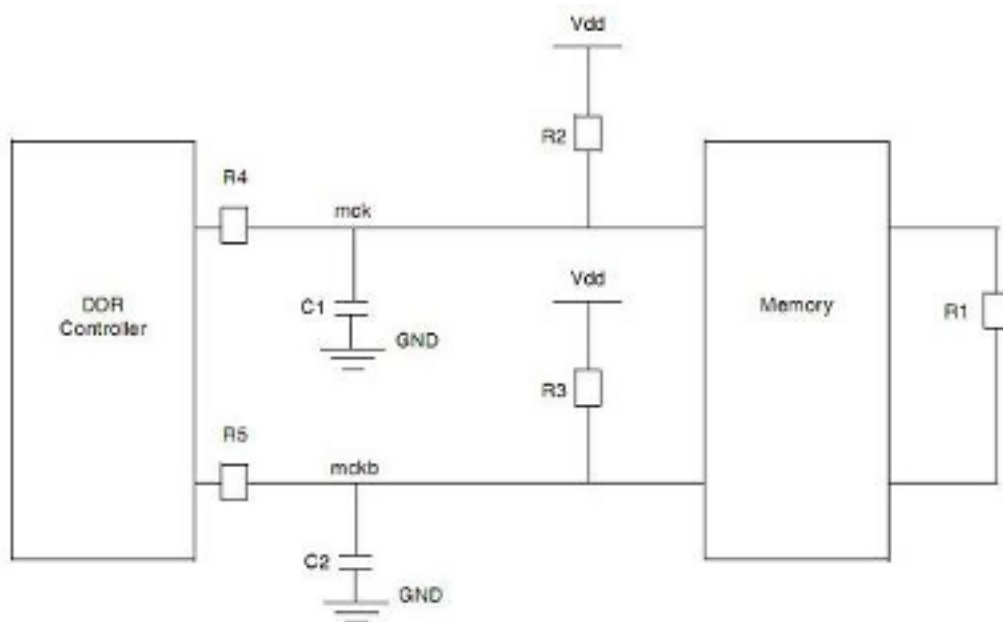
Figure 1. Recommended connections for DDR controller and memory

DDR21: MCK/ $\overline{\text{MCK}}$ AC differential crosspoint voltage outside JEDEC specifications

Description: The crossover points of the MCK and $\overline{\text{MCK}}$ signals of the DDR controller are not meeting JESD79-2C specifications, which indicates that the crossover points should lie within ± 125 mV range of reference voltage.

Impact: Disagreement with the JESD79-2C standard.

Workaround: To meet the JESD79-2C crosspoint voltage specifications, we recommend implementing the following connections between the DDR controller and DDR2 memory:

1. Increasing R2 and R3 shifts signal levels up (used as pull up).
2. Increasing C1 increases rise/fall time of mck signal.
3. Increasing C2 increases rise/fall time of mckb signal.
4. Reducing R1 can help in shifting the signals up.
5. R4 and R5 can be used to make termination proper.

R4, R5, C1, C2 near to SOC, R1, R2, and R3 have been placed at the end of clock transmission lines.

We recommend varying termination resistor R1 first. Lowering R1 can help increase the voltage levels up. The only disadvantage is that it may add up more reflections. Therefore, the user must decide accordingly. If it does not give sufficient margin, the user can add the pull-up resistor (R3 and R4) option to further increase the voltage levels.
