## MPC8309 Chip Errata

This document details all known silicon errata for the MPC8309. The following table provides a revision history for this document.

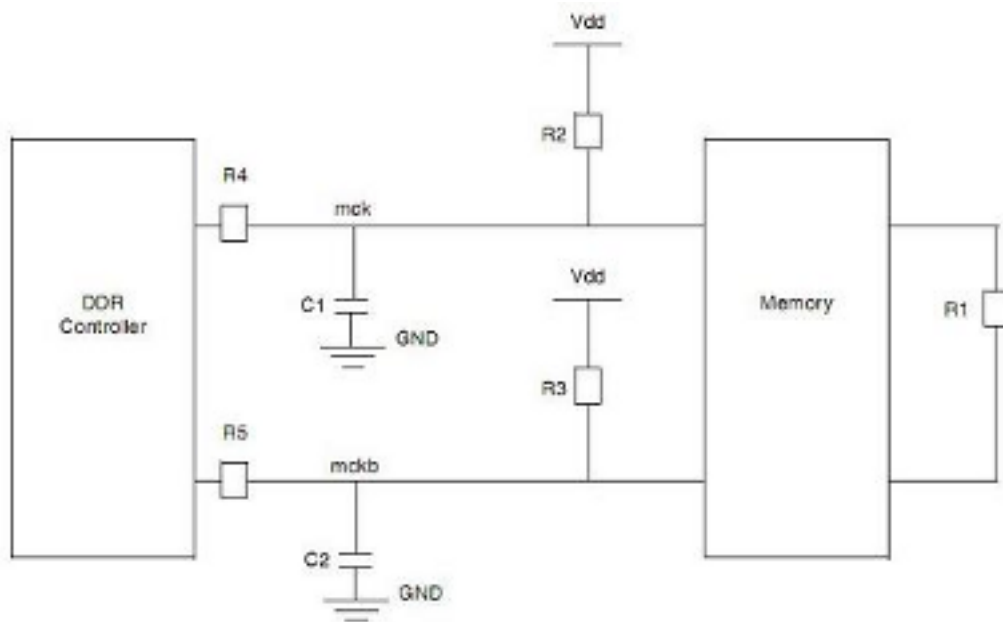
**Figure 1. Recommended connections for DDR controller and memory**

**Description:** The crossover points of the MCK and  $\overline{\text{MCK}}$  signals of the DDR controller are not meeting JESD79-2C specifications, which indicates that the crossover points should lie within  $\pm 125$  mV range of reference voltage.

**Impact:** Disagreement with the JESD79-2C standard.

**Workaround:** To meet the JESD79-2C crosspoint voltage specifications, we recommend implementing the following connections between the DDR controller and DDR2 memory:

1. Increasing R2 and R3 shifts signal levels up (used as pull up).
2. Increasing C1 increases rise/fall time of mck signal.
3. Increasing C2 increases rise/fall time of mckb signal.
4. Reducing R1 can help in shifting the signals up.
5. R4 and R5 can be used to make termination proper.

R4, R5, C1, C2 near to SOC, R1, R2, and R3 have been placed at the end of clock transmission lines.

We recommend varying termination resistor R1 first. Lowering R1 can help increase the voltage levels up. The only disadvantage is that it may add up more reflections. Therefore, the user must decide accordingly. If it does not give sufficient margin, the user can add the pull-up resistor (R3 and R4) option to further increase the voltage levels.

Exact values of components vary from design to design and some of them may not be required for all designs. We recommend that you make provisions for all these options in your design.
