# MPC5121e (M36P) Errata

by: Microcontroller Division

This document identifies implementation differences between the MPC5121e, M36P (Rev. 1), and the processor's description contained in the *MPC5121e Microcontroller Reference Manual* and the *MPC5121e Microcontroller Data Sheet*. Refer to <http://www.freescale.com> for the latest updates.

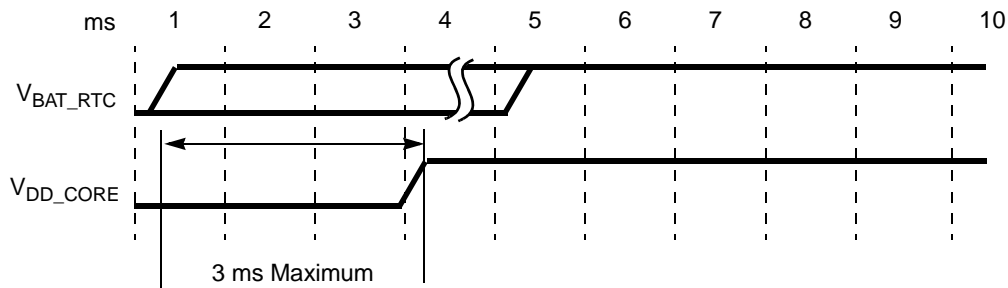
**Figure 1.  $V_{BAT\_RTC}$  to  $V_{DD\_CORE}$  Timing**

The Real-Time Clock (RTC) oscillator may not start properly when the  $V_{BAT\_RTC}$  power domain is active and  $V_{DD\_CORE}$  is transitioning from power-off to power-on.

When the  $V_{BAT\_RTC}$  power domain is active and the  $V_{DD\_CORE}$  transitions from off to on, the RTC time base becomes unreliable. The functionality of the oscillator and clock feeding the RTC counter is in one of three states:

Ensure that the  $V_{BAT\_RTC}$  power domain does not lead the  $V_{DD\_CORE}$  by more than 3 ms, or toggle  $V_{BAT\_RTC}$  after  $V_{DD\_CORE}$  has been turned on. The 3 ms is measured from  $V_{BAT\_RTC}$  at 50% to  $V_{DD\_CORE}$  at 90% of full values.

$V_{BAT\_RTC}$  can be powered concurrently with or enabled by  $V_{DD\_CORE}$ . Cycling  $V_{BAT\_RTC}$  power will result in the RTC counter being reset. See item 4 below. Following this workaround measure eliminates the need for measures 2 and 3 below.
