# Mask Set Errata for 68HC812A4, Mask 0K51E

This mask set errata applies to this 68HC812A4 MCU mask set:

- 0K51E
-

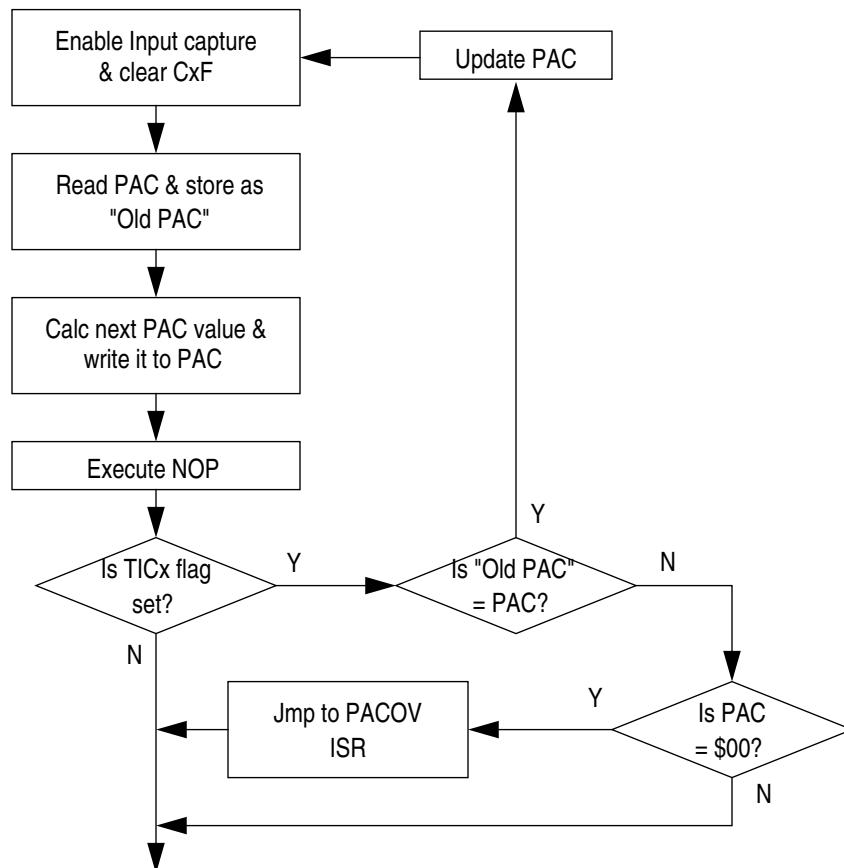
**HC12\_AR\_645: ECT  
PA Overflow flag not set when event is concurrent with write of \$FFFF****Description**

When the value \$FFFF is written to PACA or PACB and, at the same time, an external clocking pulse is applied to the PAC, the pulse accumulator may overflow from \$FFFF to \$0000, but the pulse accumulator overflow flag [PAFLG,PBFLG] is not set. Same situation may happen with 8-bit pulse accumulators PAC1 and PAC3.

The input capture function for the subject channel be enabled prior to writing a value to the PACA or PACB. Write to the pulse accumulator register. Then do one NOP (to allow the input capture to update the interrupt flag) followed by a read of the input capture interrupt flag to see if it set. If yes, a check must be made for a missing pulse accumulator event. Steps for software workaround to see if event happens while writing to PAC:

1. Enable Input Capture on same pin as the pulse accumulator (and same type of event).
2. Clear the appropriate CxF in the timer interrupt flag register.
3. Read PAC and store as “Old PAC”.
4. Calculate desired PAC value and write it to the PAC.
5. Execute 1 NOP.
6. Read CxF in the timer interrupt flag register.

If flag is not set, done (no events happened while writing to the PAC).

If flag is set read PAC

If “Old PAC” = PAC, then update PAC (event happened while writing to PAC and the PAC did

not capture it). Note, if the updated PAC value is \$00 jump to PACOV ISR.

If "Old PAC" does not equal PAC, does PAC = \$00 ?

If yes, jump to PACOV ISR.

If no, done (event happened while writing to the PAC and PAC captured it). Read CxF in the timer interrupt.
