Mask Set Errata for 68HC812A4, Mask 0L00N

This mask set errata applies to this 68HC812A4 MCU mask set:

- 0L00N

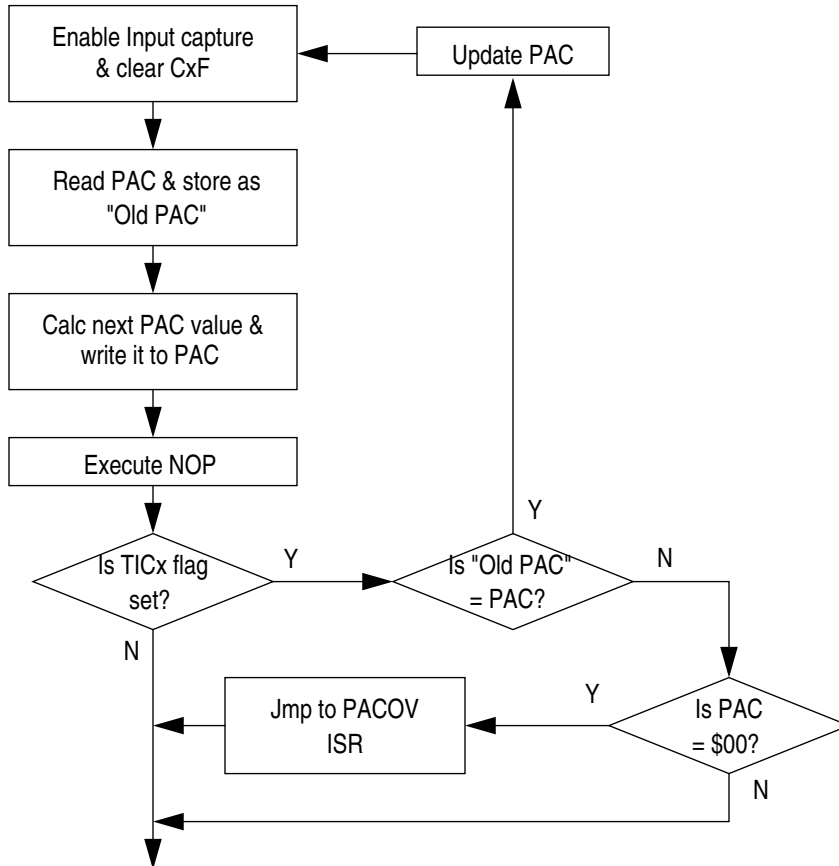
When the value \$FFFF is written to PACA or PACB and, at the same time, an external clocking pulse is applied to the PAC, the pulse accumulator may overflow from \$FFFF to \$0000, but the pulse accumulator overflow flag [PAFLG,PBFLG] is not set. Same situation may happen with 8-bit pulse accumulators PAC1 and PAC3.

The input capture function for the subject channel be enabled prior to writing a value to the PACA or PACB. Write to the pulse accumulator register. Then do one NOP (to allow the input capture to update the interrupt flag) followed by a read of the input capture interrupt flag to see if it set. If yes, a check must be made for a missing pulse accumulator event. Steps for software workaround to see if event happens while writing to PAC:

1. Enable Input Capture on same pin as the pulse accumulator (and same type of event).
2. Clear the appropriate CxF in the timer interrupt flag register.
3. Read PAC and store as "Old PAC".
4. Calculate desired PAC value and write it to the PAC.
5. Execute 1 NOP.
6. Read CxF in the timer interrupt flag register.

If flag is not set, done (no events happened while writing to the PAC).

If flag is set read PAC

If "Old PAC" = PAC, then update PAC (event happened while writing to PAC and the PAC did

not capture it). Note, if the updated PAC value is \$00 jump to PACOV ISR.

If "Old PAC" does not equal PAC, does PAC = \$00 ?

If yes, jump to PACOV ISR.

If no, done (event happened while writing to the PAC and PAC captured it). Read CxF in the timer interrupt.
