Mask Set Errata for Mask 2L71Y

This mask set errata applies to the mask 2L71Y for these products:

- MC9S08RE16
- MC9S08RE8
- MC9S08RD16
- MC9S08RD8
- MC9S08RC16
- MC9S08RC8

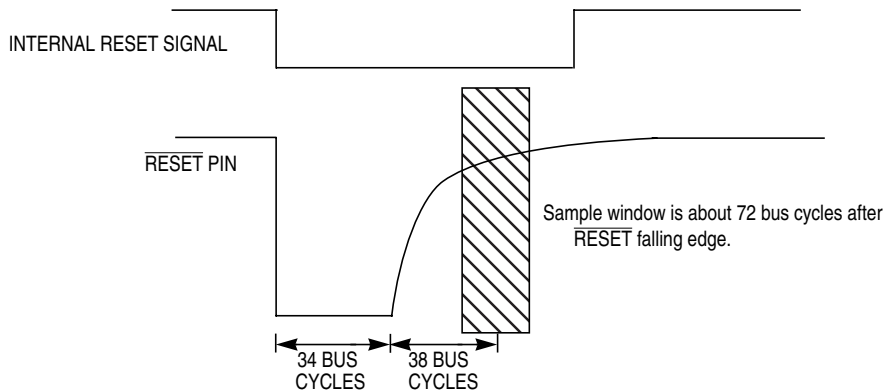
Case 1 — After detecting a reset signal, either internal or external, the internal reset circuit latches the cause of the reset, forces a low level on the external $\overline{\text{RESET}}$ pin for about 34 bus cycles, releases the pin, and samples the pin level about 38 bus cycles later.

To avoid multiple edges on the $\overline{\text{RESET}}$ pin due to switch contact ringing or EMC noise, eliminate any voltage bounce through RC filtering. A 0.1 μF capacitor to ground and an external 4.7 k Ω to 10 k Ω resistor to V_{DD} works well to ensure noise suppression.
