Mask Set Errata

MSE912DT128A_0L05H
Rev 0.0, 01/2003

Mask Set Errata for
68HC912DT128A
Mask 0L05H

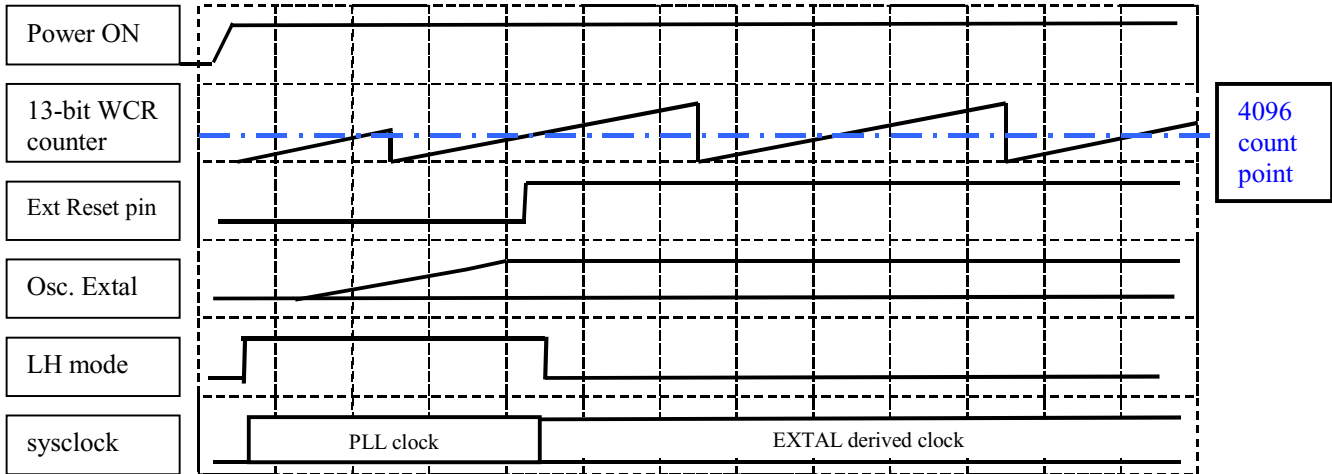
Figure 1. Representation of Normal start-up condition

Common practice for the start up mode of operation of HC12 microcontrollers is for the external RESET line to be held active until such time as the crystal has stabilized at its operating frequency. On release of the external RESET line and when the WCR (counter register) reaches a count of 4096 cycles, normal operating mode is entered with the CPU clocked from the crystal frequency (see fig. 1).

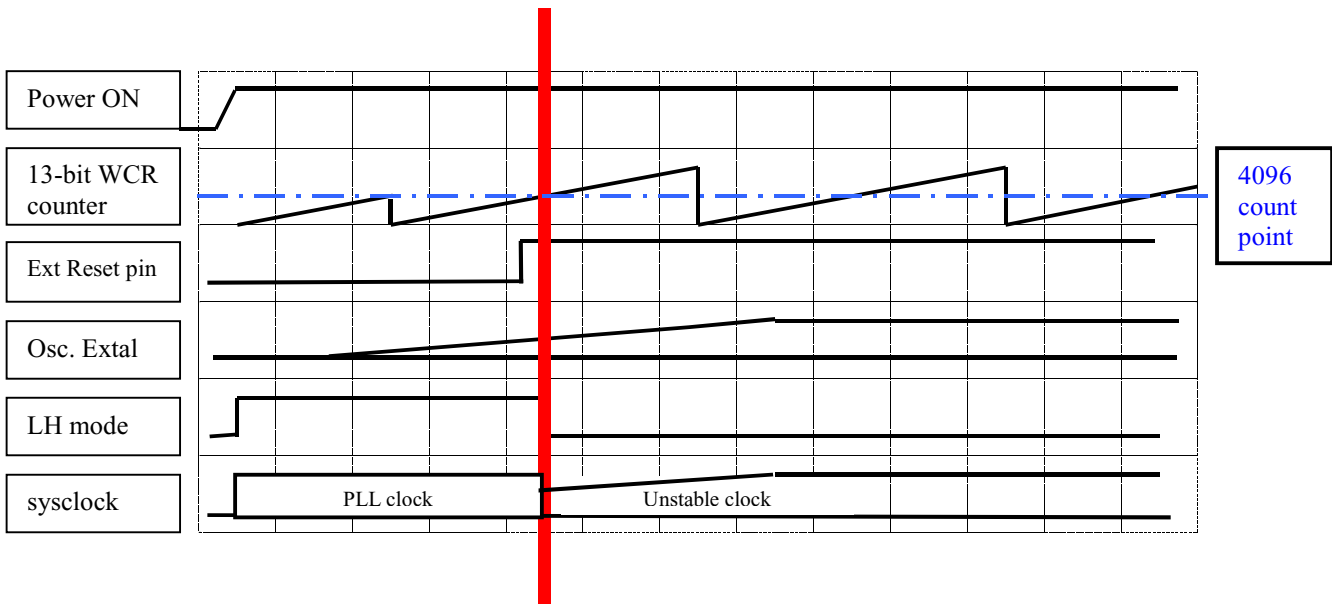
Figure 2. Representation of unreliable start-up mode with slow crystal

The device can prematurely indicate that the oscillator has stabilized releasing the part from Limp Home clock mode to the oscillator clock mode with an unstable oscillator. This can cause unpredictable behavior of the MCU. This situation can arise with short external power-on reset periods and / or crystal oscillator circuits that exhibit slow startup characteristics. If the PLL is not being used (Vddpll connected to Vss) Limp Home mode is disabled and this issue does not apply.

For the first 4096 cycles i.e. during the internal reset period, Limp Home mode will be de-asserted if oscillator activity is detected by the clock monitor circuit - due to the asserted Reset signal there can be no CPU activity during the Reset phase. Following release of the external or internal POR RESET in LHM (whichever is later) the crystal oscillator is sampled by the clock monitor circuit after another 4096 VCO clock cycles and at intervals of 8192 clock cycles thereafter until the crystal is deemed to be operating. If the crystal oscillator is showing activity at the time it is checked then it will be deemed to be good, even though it may not have fully stabilized, and LHM will be de-asserted. This can cause the device to switch from LH mode to normal mode with the CPU clocked from an unstable signal from the crystal oscillator (see fig. 2) resulting in unpredictable function of the CPU.
