# TWR-AUDIO-SGTL Tower Module

## Hardware Errata and Changes

Rev. 0.3

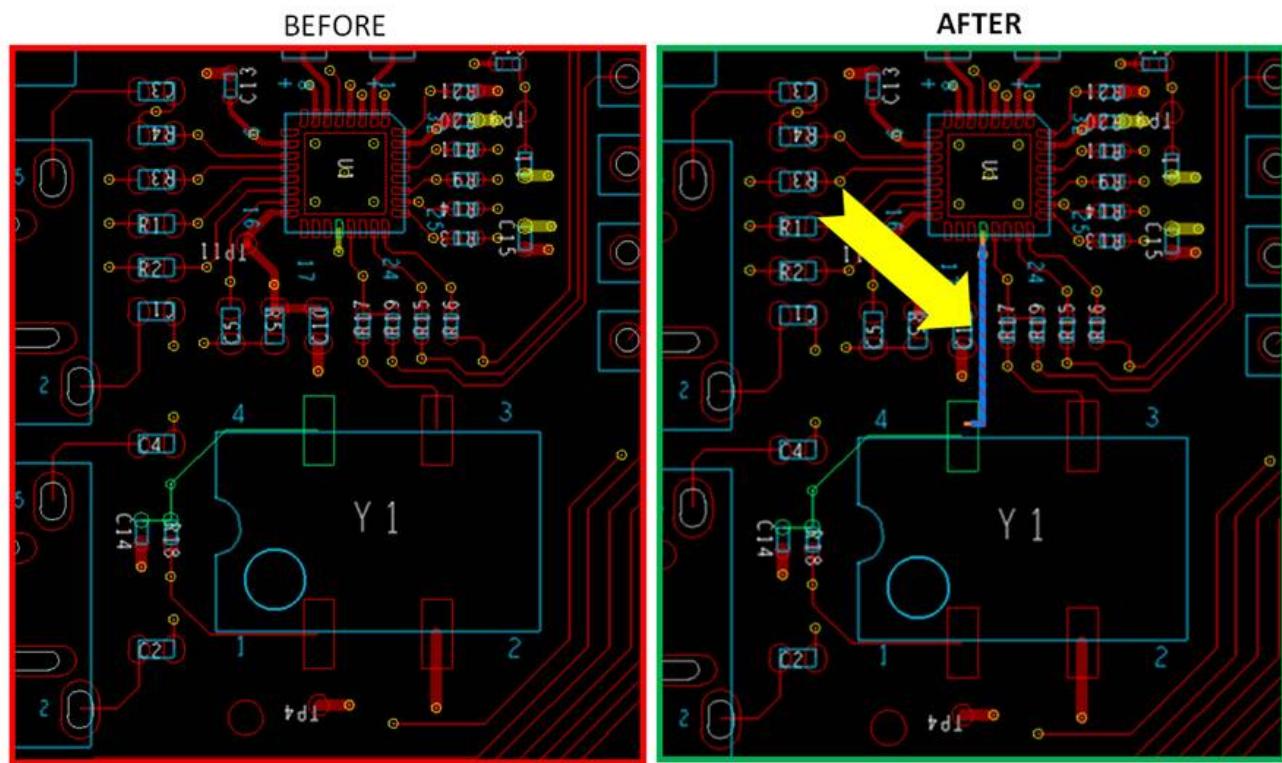
There is no power connected to the power pin of the crystal oscillator (pin4 of Y1).

Add wire as shown below.

CONNECT JUMPER CABLE FROM Y1/PIN4 TO U1/PIN20 (Net+3V3)
