Test Report

號碼(No.): ETR22201166

樣品名稱(Sample Name) 樣品型號(Style/Item No.)	:	COPPER FOIL COPPER FOIL M-002
=====================================	===== : :	09-Feb-2022 09-Feb-2022 to 15-Feb-2022
測試需求(Test Requested) :		依據客戶指定‧測試鹵素-氯、溴。(As specified by client, to test Halogen- Chlorine, Bromine in the submitted sample.)
測試結果(Test Results) :		請參閱下一頁 (Please refer to following pages.)

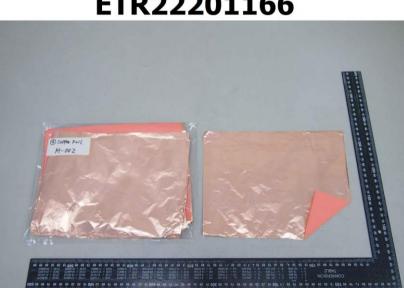
ETR22201166

> *照片中如有箭頭標示,則表示為實際檢測之樣品/部位.* (The tested sample / part is marked by an arrow if it's shown on the photo.)
